# Manhole Inspection Summary

Manhole # S05WW\_004MH

Insp Date: **7/17/07 10:52 AM**

**Location** Address: **3101 GARRISON AVE**

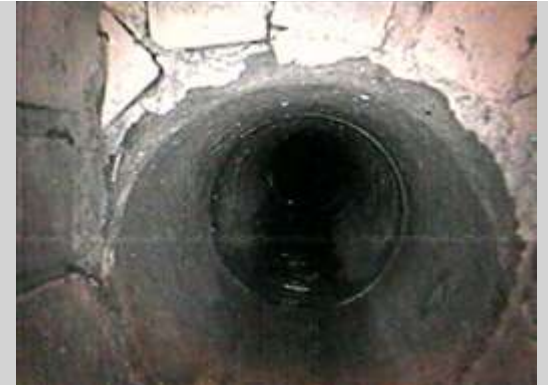
12 O'Clock Outflow

8 in. Circular Gravity Sewer  
Pipe Out @ 12 O'Clock

Pipe Height: (in.) Direct  
Pipe Material: **Clay** ☐ Pipe Lined  
Invert Depth: **8.02** (ft.) Flow Characteristics: **Slow**  
Deposits: ☒ None ☐ Mud ☐ Sludge ☐ Debris ☐ Grease  
Silt Depth: (in.) Deposits Extent:  
Infiltration: **None** Pipe Seal Cond: **Sound**

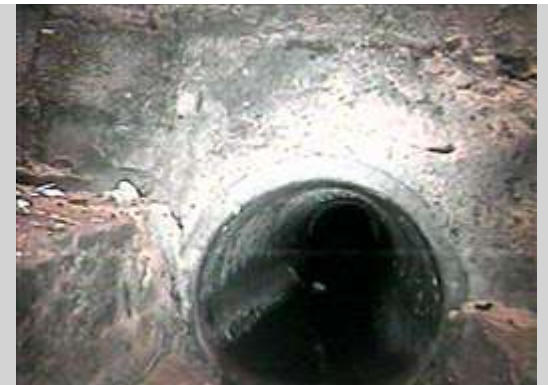
6 O'Clock Inflow

6 in. Circular Gravity Sewer  
Pipe In @ 6 O'Clock

Pipe Height: (in.) Direct  
Pipe Material: **Clay** ☐ Pipe Lined  
Invert Depth: **7.12** (ft.) Flow Characteristics: **Slow**  
Deposits: ☒ None ☐ Mud ☐ Sludge ☐ Debris ☐ Grease  
Silt Depth: (in.) Deposits Extent:  
Infiltration: **None** Pipe Seal Cond: **Sound**

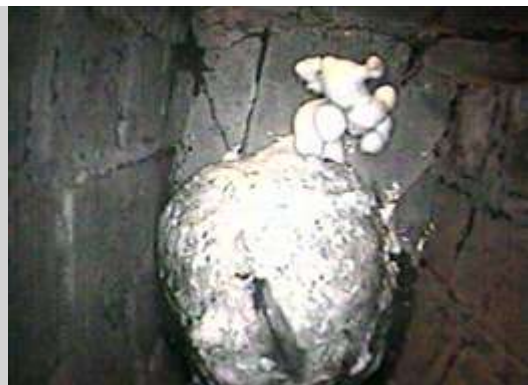
8 O'Clock Inflow

6 in. Circular Gravity Sewer

Pipe In @ 8 O'Clock

ABANDONED

Invert Depth: **8.00** (ft.) Flow Characteristics: **None**

Infiltration: **None** Pipe Seal Cond: **Unknown**

Connects To: **Dead End**
